## Superior Engineering PART LISTING

### **Installation Instructions**

Part Description: Ranger / BT50 REVO CHASSIS BRACE

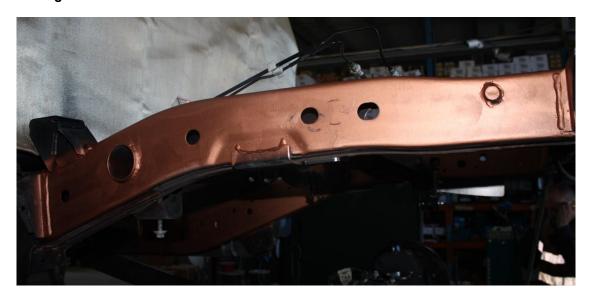
Figure 1: Clamp Outer plates into position and mark for chassis preparation prior to welding

- Before starting any work, make sure that the chassis is straight and true according to OE specification. Make sure it has no cracks or fractures that need prior attention before fitting this item.
- Raise and support the vehicle safely. Remove the rear tires and the inner guards if the vehicle has a Ute tub.
- One side at a time Clamp the superior engineering Chassis repair Plate into position. Equally position the plates to provide adequate room to weld each edge. SAFE Removal and storage of the fuel tank is required to install lower brace on the Passenger side.
- 4. Trace around the Superior Engineering chassis repair plate, leaving a line around the outside using a marker.
- 5. Remove the Superior Engineering chassis repair brace.

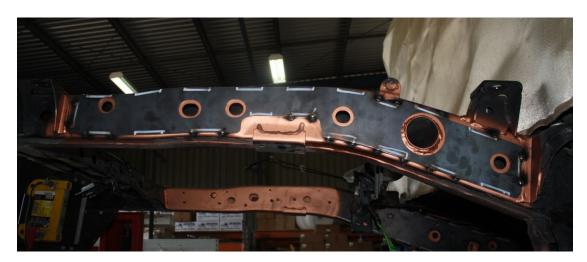
Figure 2: Correct Location Of Chassis Brace Item #1 - Drivers Side

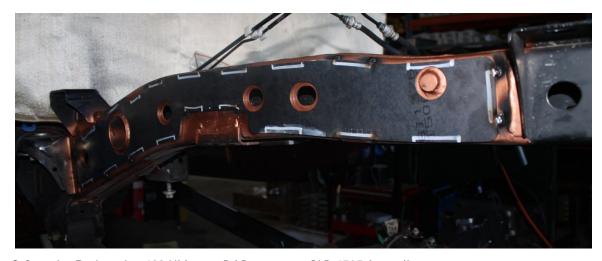
Figure 3: Correct Location Of Chassis Brace Item #2 - Passenger Side

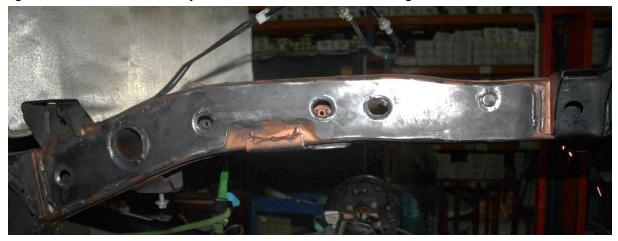
Figure 4: Brace welded in position and cleaned - Passenger Side

- Clamp the Superior Engineering chassis repair plate back in to position ready to weld.
- Weld the plate to the chassis using the correct welding procedure. Stagger/Intermittent welds 50-50mm or practicable. Larger circle cut-outs may be welded.

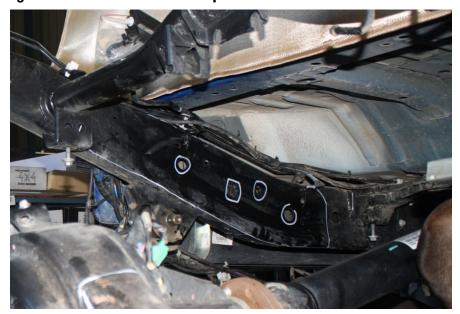
Figure 5: Inner Brace chassis position

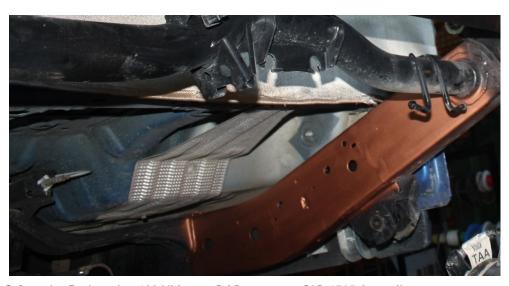
Figure 6: Inner chassis Plate location and preparation prior to welding

6. Prep the chassis for welding by cleaning all paint off the area that is required.

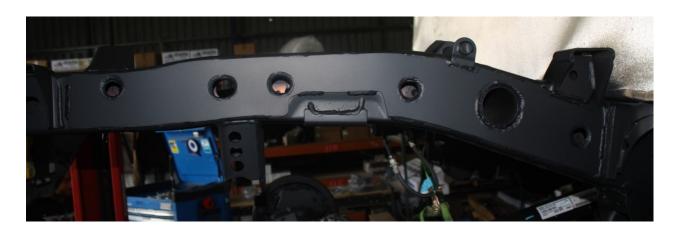
Figure 7: Brace with rust prevention re-applied and painted - Drivers Side

- 9. REPEAT procedure for the other side.
- 10. Reapply the rust proofing inside and out of the chassis as the heat from being welded will burn it off. NOTE: It is also highly recommended to repaint the chassis and the repair plate to prolonged life span preventing against rust. Any edges of the chassis brace that are not welded seal with a suitable sealant E.G. Sikaflex.

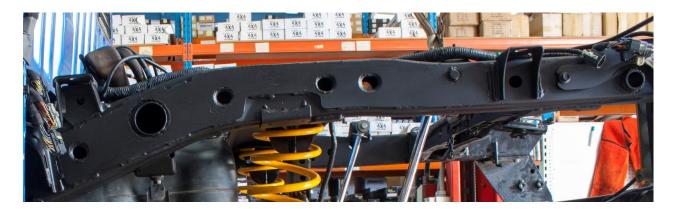
Figure 8: Brace with rust prevention re-applied and painted - Passenger Side
